NUMBER: 19-005-07

GROUP: Steering

**SUBJECT:** Проблема: Скрипит рулевой колонки в районе моторного щита  
Steering Column Dash Seal Squeak/Rubbing Sound

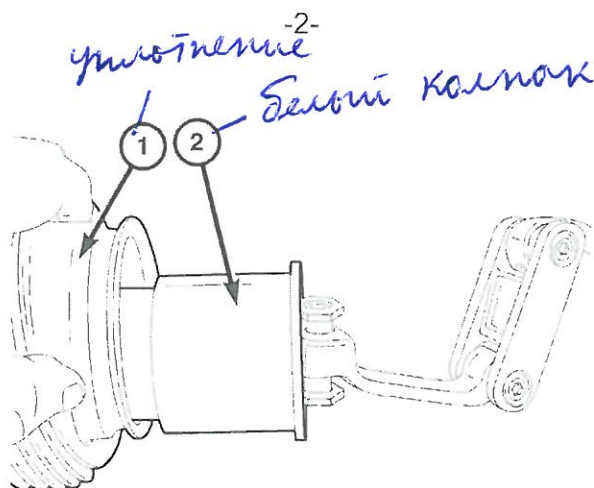
**SYMPTOM/CONDITION:** Симптомы: Владелец может пожаловаться на  
The vehicle operator may experience a squeak/rubbing sound originating from the lower steering shaft dash seal. The sound may be due to a lack of lubricant.

1. Remove the 2 push pins from the lower hush panel below the steering column
2. Remove hush panel to gain access to lower steering column seal
3. Pull the steering column seal down and inspect the white cup the seal rides on.
4. Does the white cup have black markings on white cup in the area shown in (Fig. 1) below?

Fig. 1 BLACK MARKING ON WHITE CUP

- 1 - STEERING COLUMN DASH SEAL  
2 - WHITE CUP (AREA OF BLACK MARKINGS)

- a. No >>> Perform Repair Procedure A  
b. Yes >>> Perform Repair Procedure B

1. While the seal is down, clean seal lip and white cup.
2. Apply grease p/n 68028730AA to cup.
